**FAWN LAKE  
 INUNDATION ZONES**

**Dewberry**

August 3, 2017

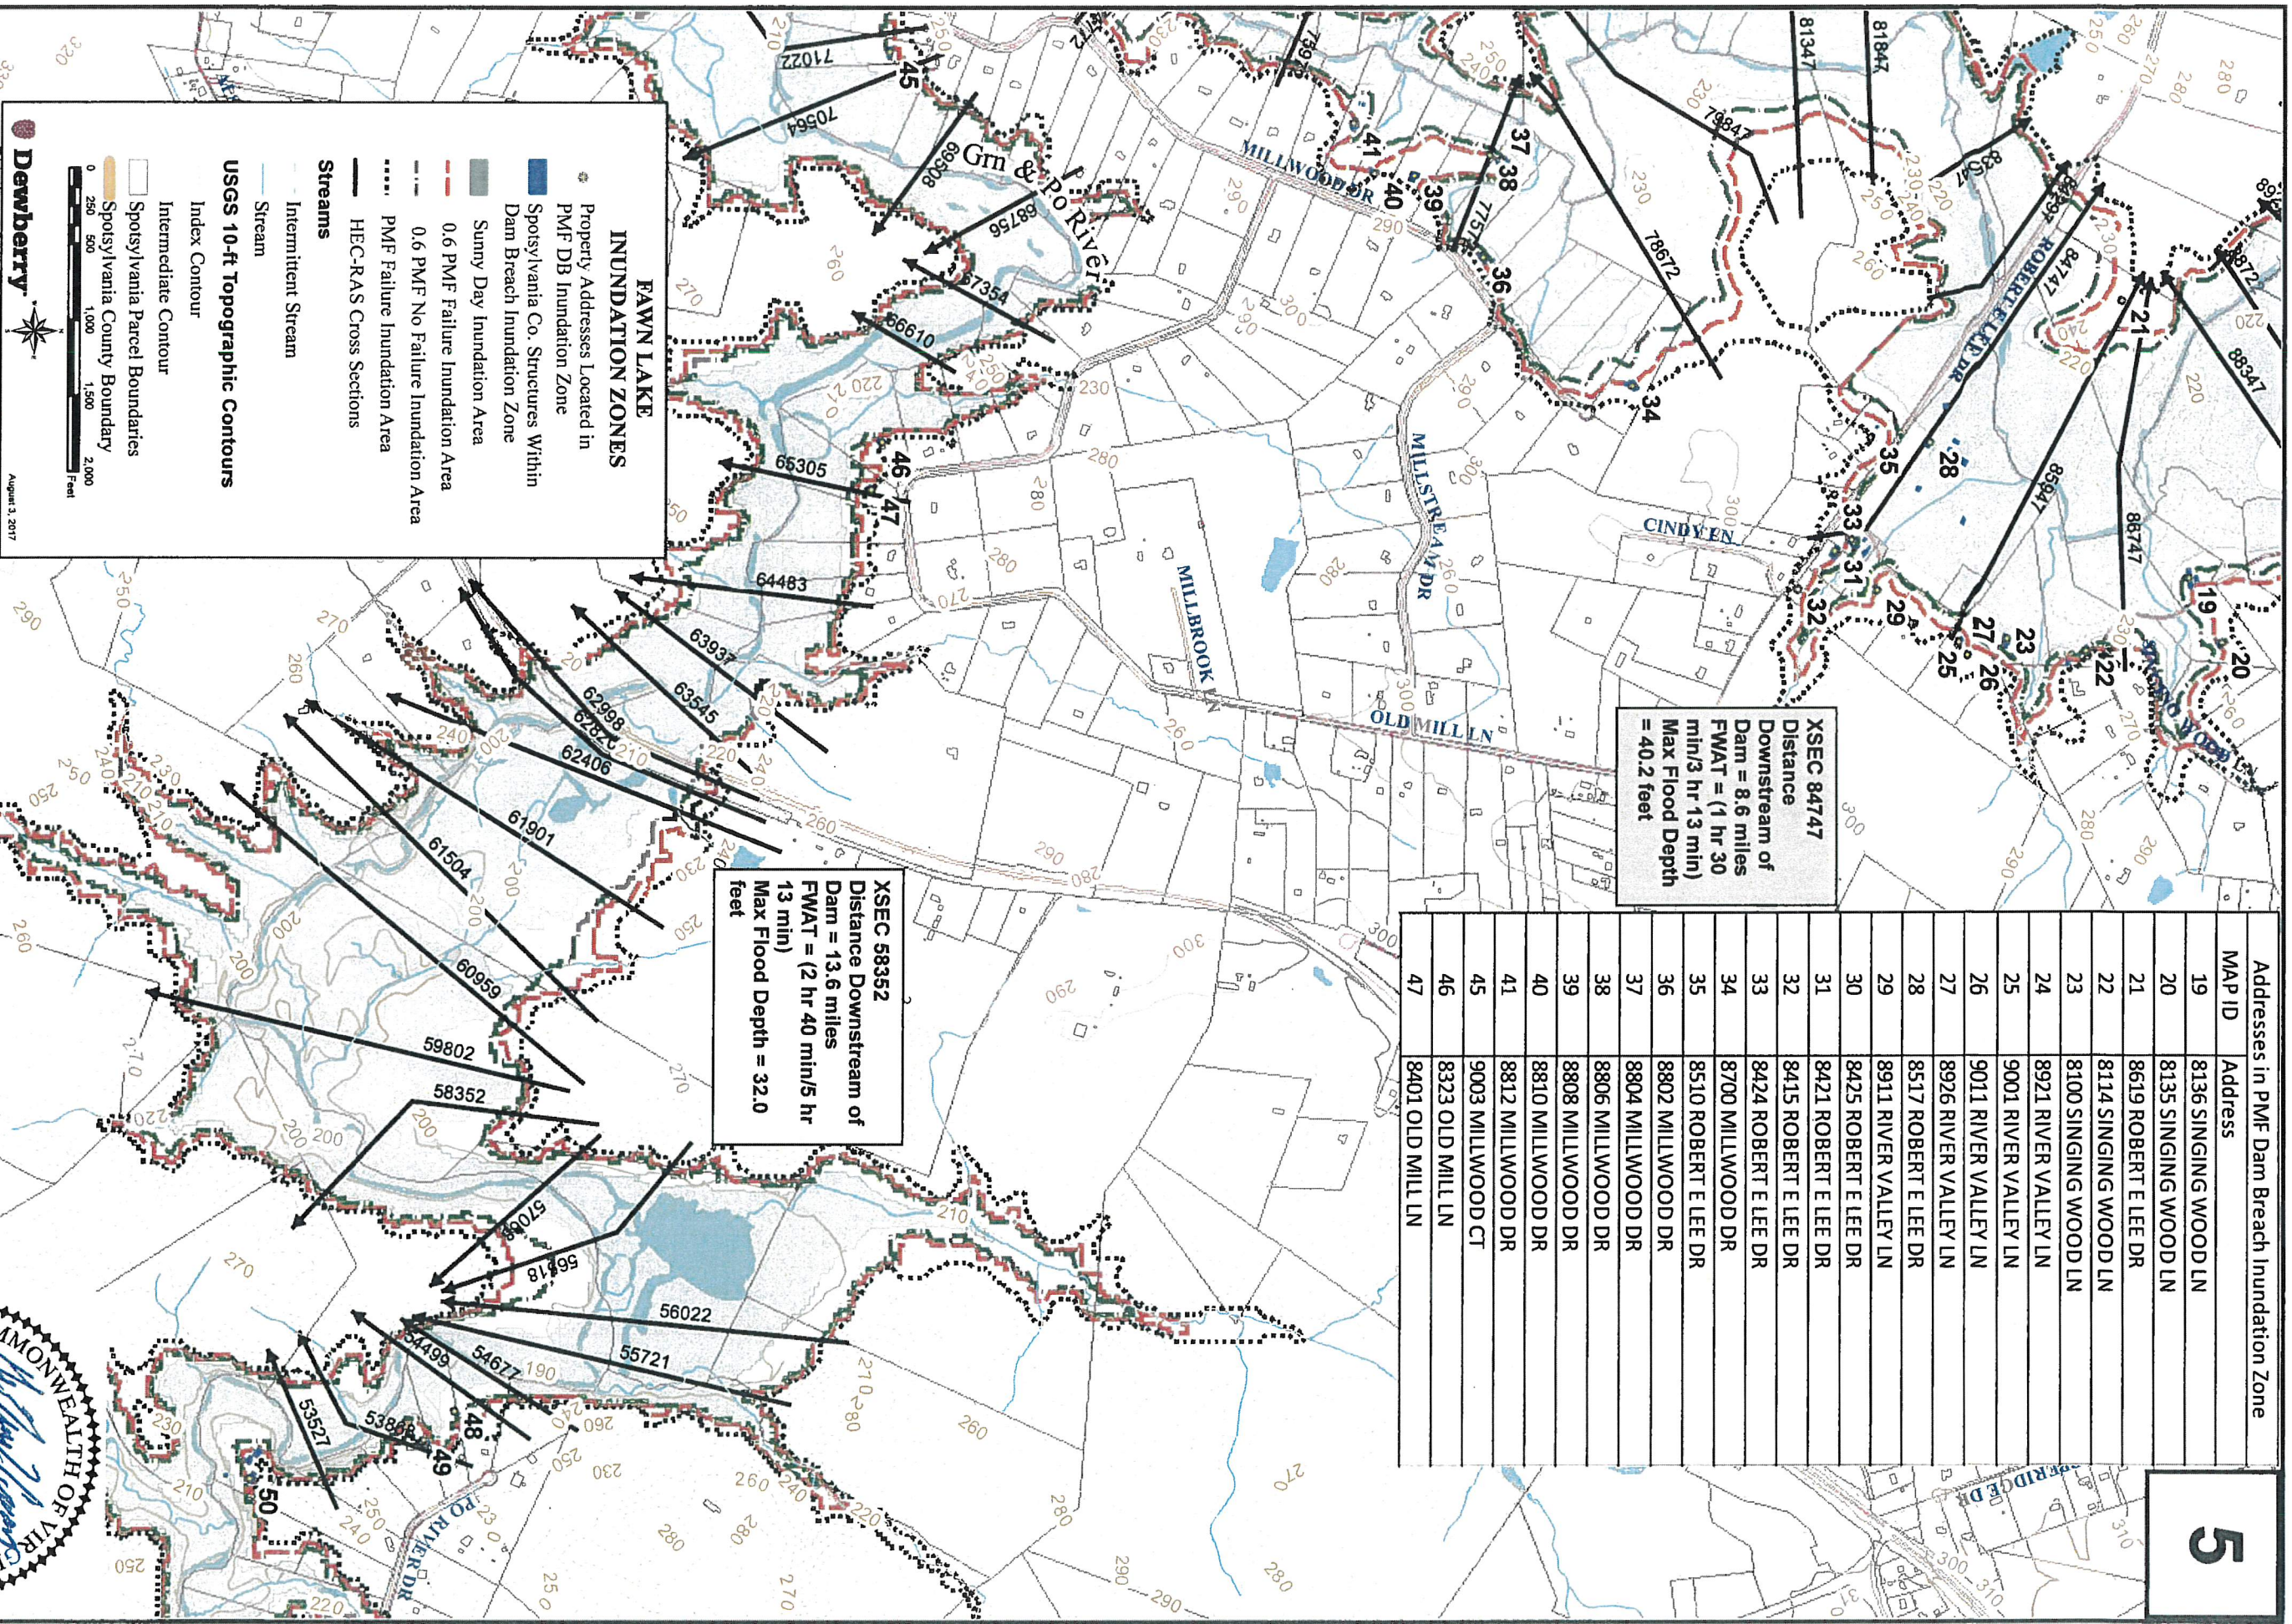
**XSEC 84747**  
 Distance  
 Downstream of  
 Dam = 8.6 miles  
 FWAT = (1 hr 30  
 min/3 hr 13 min)  
 Max Flood Depth  
 = 40.2 feet

**XSEC 58352**  
 Distance Downstream of  
 Dam = 13.6 miles  
 FWAT = (2 hr 40 min/5 hr  
 13 min)  
 Max Flood Depth = 32.0  
 feet
