**FAWN LAKE  
INUNDATION ZONES**

Dewberry

August 3, 2017

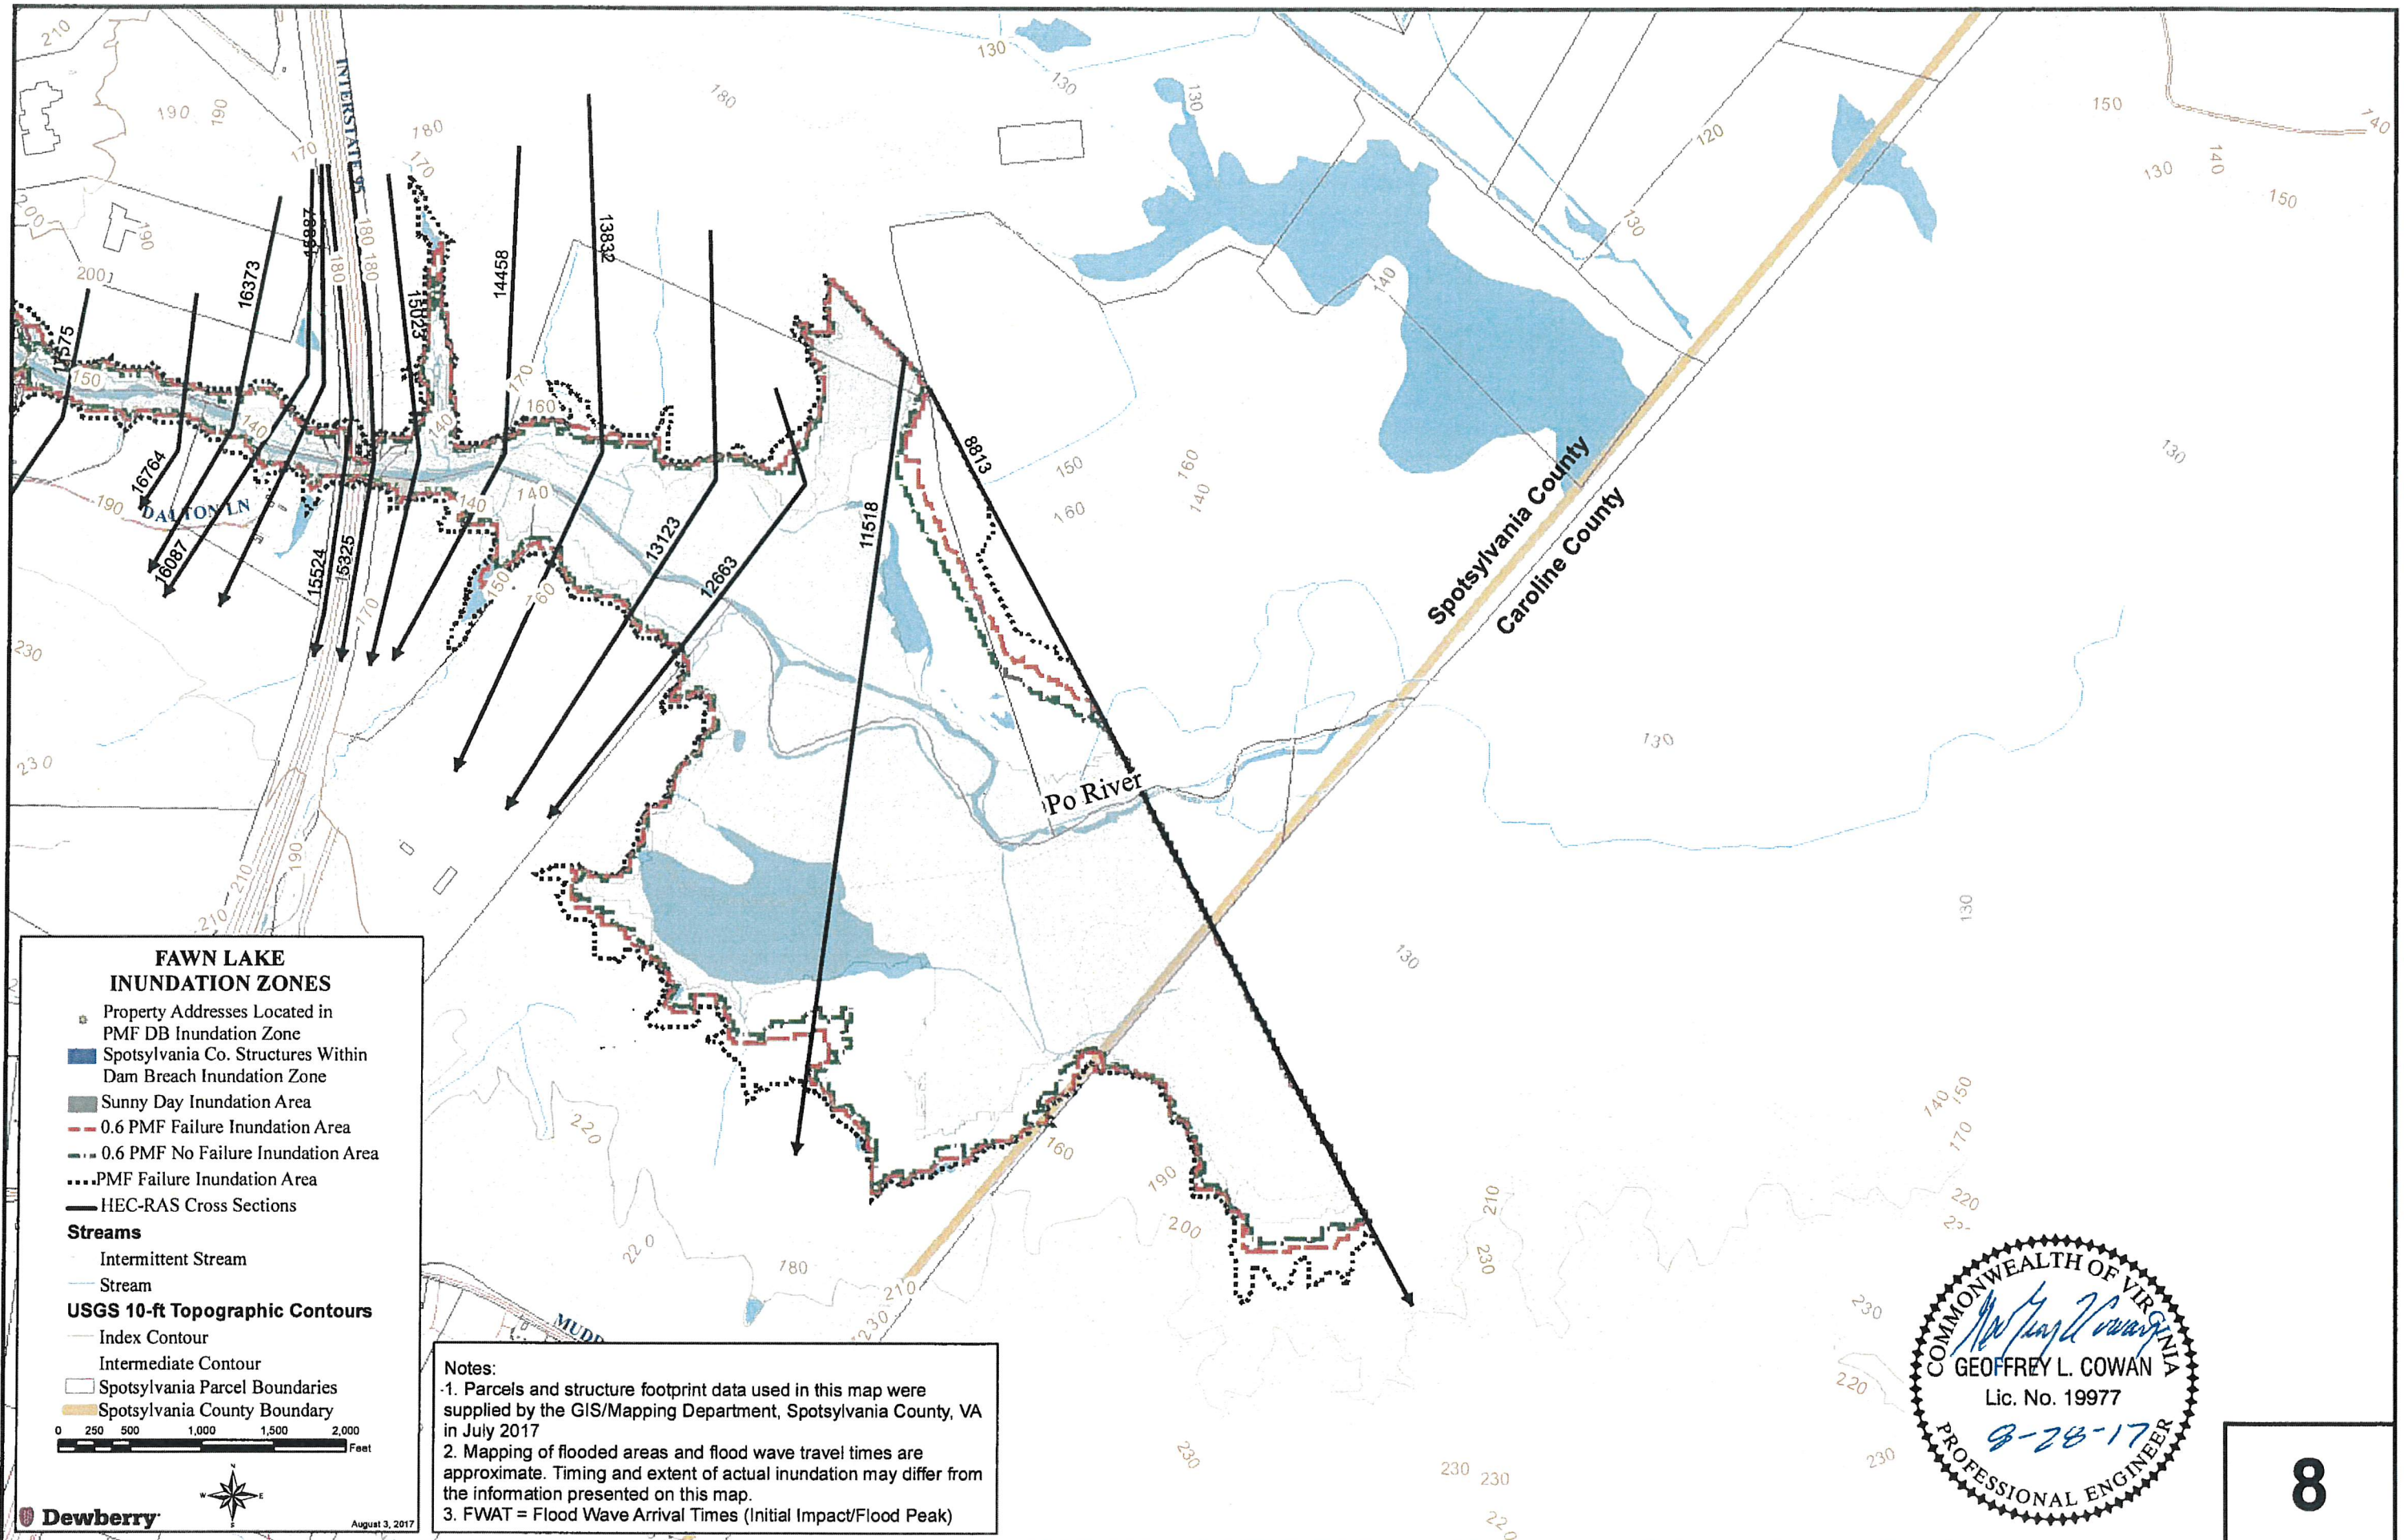
- Property Addresses Located in PMF DB Inundation Zone
- Spotsylvania Co. Structures Within Dam Breach Inundation Zone
- Sunny Day Inundation Area
- - - 0.6 PMF Failure Inundation Area
- - - 0.6 PMF No Failure Inundation Area
- ... PMF Failure Inundation Area
- HEC-RAS Cross Sections
- Streams**
- Intermittent Stream
- Stream
- USGS 10-ft Topographic Contours**
- Index Contour
- Intermediate Contour
- Spotsylvania Parcel Boundaries
- Spotsylvania County Boundary

**Notes:**  
 -1. Parcels and structure footprint data used in this map were supplied by the GIS/Mapping Department, Spotsylvania County, VA in July 2017  
 -2. Mapping of flooded areas and flood wave travel times are approximate. Timing and extent of actual inundation may differ from the information presented on this map.  
 -3. FWAT = Flood Wave Arrival Times (Initial Impact/Flood Peak)
