EMERGENCY ACTION PLAN

FAWN LAKE DAM
SPOTSYLVANIA COUNTY, VIRGINIA

Inventory Number: 177009

March 3, 2020

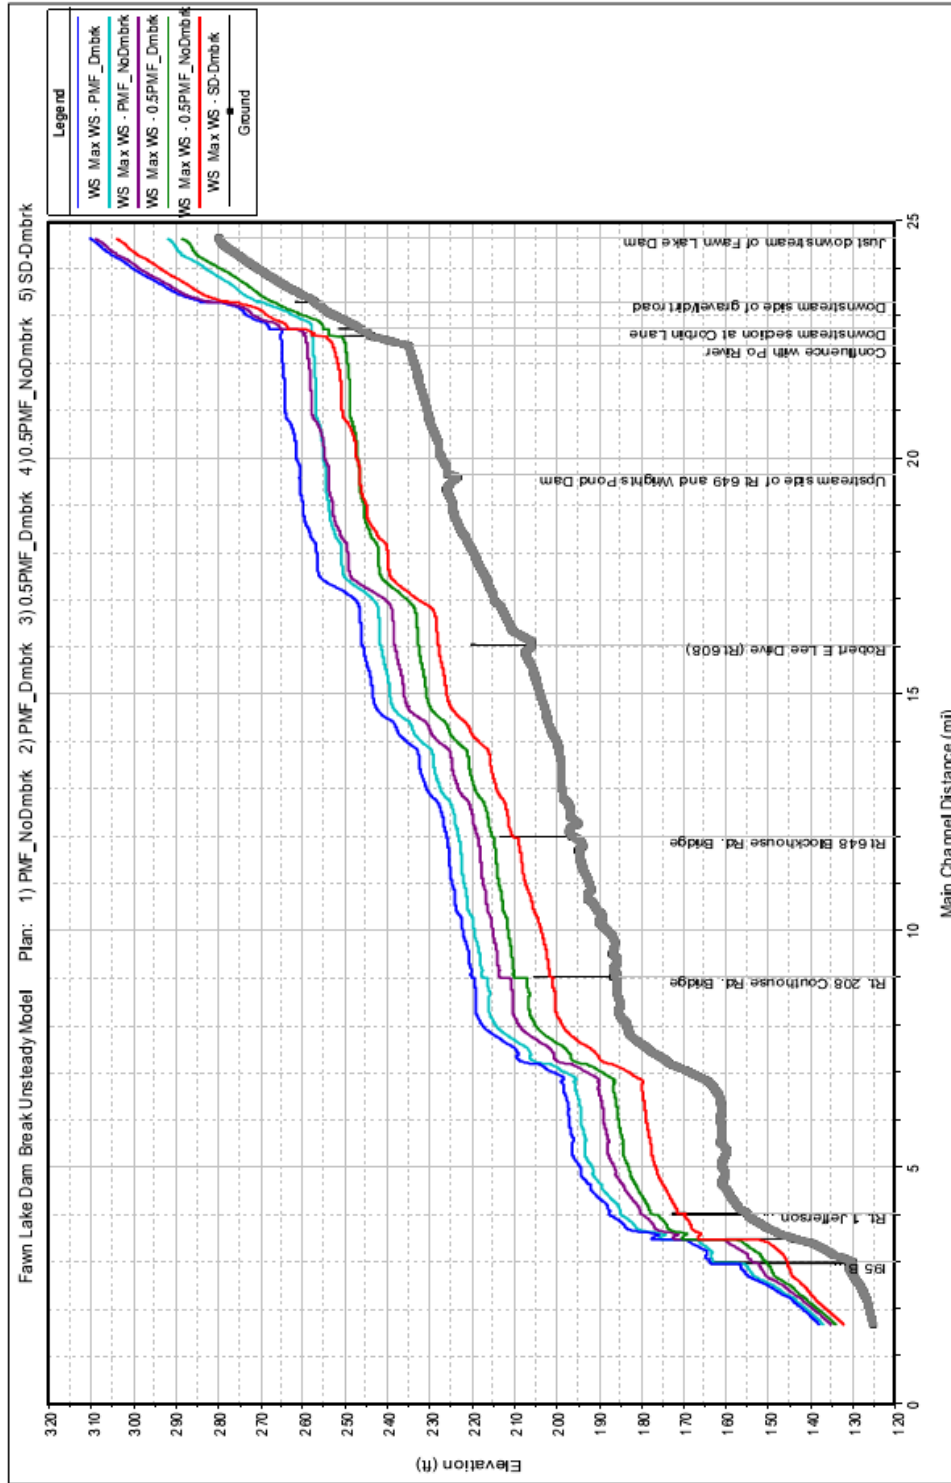
Figure 5. Maximum Water Surface Elevation Profiles.

Appendix E –Flood Depths

The analysis extended from the Fawn Lake Dam to a point just approximately 1.6 miles downstream of Interstate 95 and approximately 1.6 miles upstream of the confluence of the Po and Ni Rivers. The inundation zone ends approximately 14 miles downstream of the dam at the confluence of the Po and Ni Rivers. Inundation maps showing the area that would be inundated by a sunny day breach and a PMF breach as well as failure flood profiles for the floodplain are included in Section VII and Appendix E.

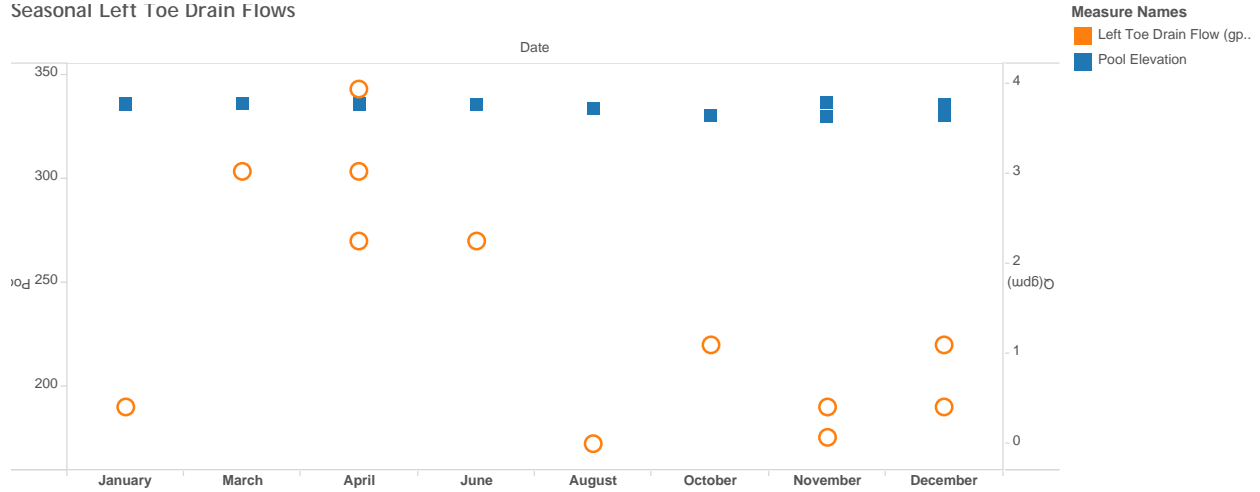
Seasonal Left Toe Drain Flows

There is a weir box located to the left the principal spillway that measures the quantity of flow from the left toe drain and lake pool elevations. Flows outside these ranges are a potential indicated of a developing problem and should be addressed in a timely manner.

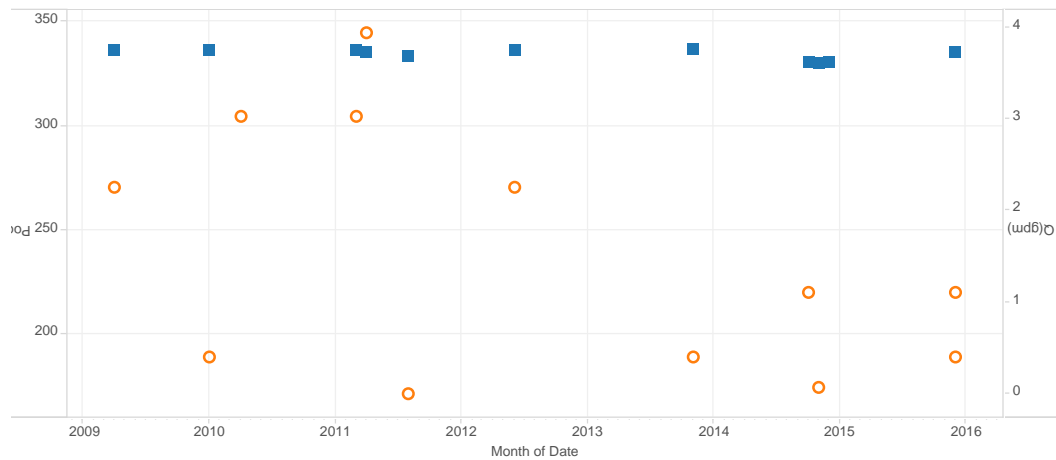
Left Toe Drain Flows over Time

Flow Rates for a 90 degree V-Notch Weir where H is the depth of water measured at the upstream side of the weir box

Flow Rates for a V Notch Weir

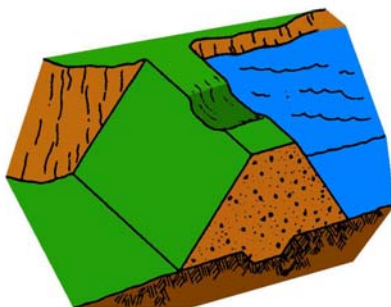
LOW AREA IN CREST OF DAM

1. Excessive settlement in the embankment or foundation directly beneath the low area in the crest.
2. Internal erosion of embankment material.
3. Foundation spreading toward upstream and/or downstream direction.
4. Prolonged wind erosion of crest area.
5. Improper final grading following construction.

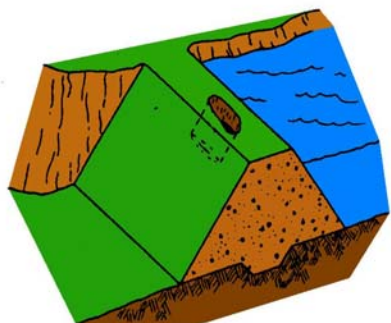
SINKHOLE IN CREST

1. Rodent activity.
2. Hole in outlet conduit is causing erosion of embankment material.
3. Internal erosion or piping of embankment material by seepage.
4. Breakdown of dispersive clays within embankment by seepage waters.

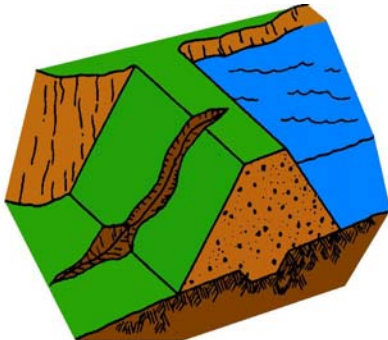
GULLY ON CREST

1. Restore freeboard to dam by adding fill material in low area, using proper construction techniques.
2. Re-grade crest to provide proper drainage of surface run-off.
3. If gully was caused by over-topping, provide adequate spillway which meets current design standards. This should be done by engineer.
4. Re-establish protective cover.

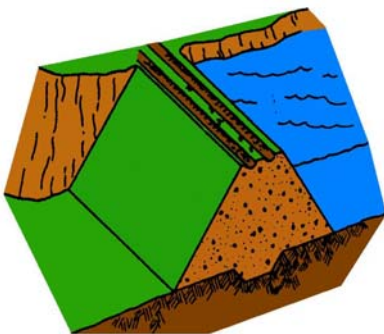
RUTS ALONG CREST

Heavy vehicular traffic without adequate or proper maintenance or proper crest surfacing.

1. Drain standing water from ruts.
2. Re-grade and re-compact crest to restore integrity and provide proper drainage toward upstream slope.
3. Provide gravel or road base material to accommodate traffic.
4. Perform periodic maintenance and re-grading to prevent reformation of ruts.

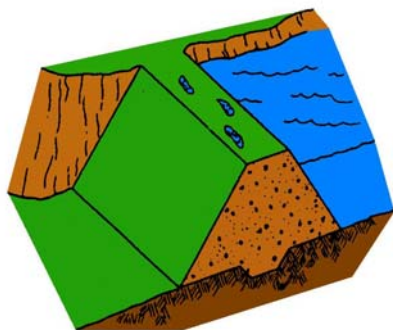
PUDDLING ON CREST; POOR DRAINAGE

1. Poor grading and improper drainage of crest.
2. Localized consolidation or settlement on crest allows puddles to develop.

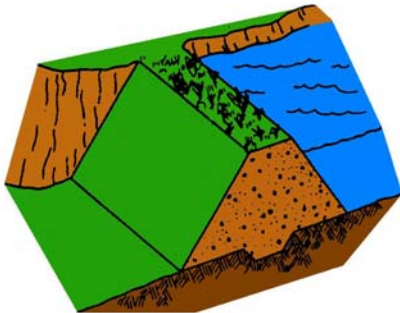
OBSCURING VEGETATION

1. Remove all detrimental growth from the dam. This would include removal of trees, bushes, brush, conifers, and growth other than grass. Grass should be encouraged on all segments of the dam to prevent erosion by surface run-off. Root systems should also be removed to the maximum practical extent. The void which results from removing the root system should be backfilled with competent, well-compacted material.
2. Future undesirable growth should be removed by cutting or spraying, as part of an annual maintenance program.
3. All cuttings or debris resulting from the vegetative removal should be immediately taken from the dam and properly disposed of outside the reservoir basin.

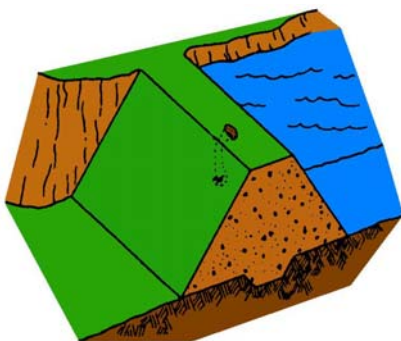
RODENT ACTIVITY ON CREST

Burrowing animals.

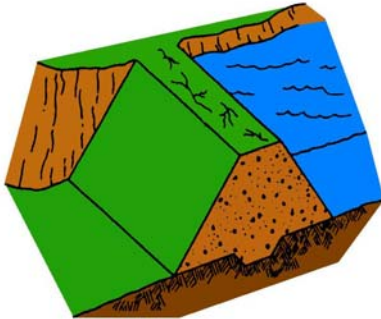
DRYING CRACKS

1. Seal surface of cracks with a tight, impervious material.
- or...
2. Routinely grade crest to provide proper drainage and till cracks.
- or...
3. Cover crest with non-plastic (not clay) material to prevent large moisture content variations with respect to time.
4. Draw the reservoir down if safety of dam is threatened.

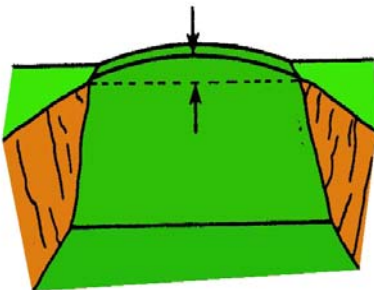
CREST CAMBER

Results from construction. Proportionally more fill is placed on crest in higher segments of the embankment during construction to compensate for anticipated settlement within the dam and foundation.

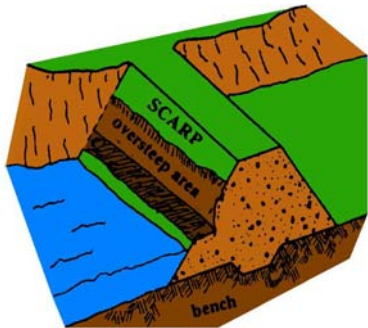
SCARPS, BENCHES, OVERSTEEP AREAS

Wave action, local settlement, or ice action cause soil and rock to erode and slide to the lower part of the slope forming a bench.

Determine exact cause of scarps. Do necessary earthwork, restore embankment to original slope, provide adequate protection (bedding and riprap).

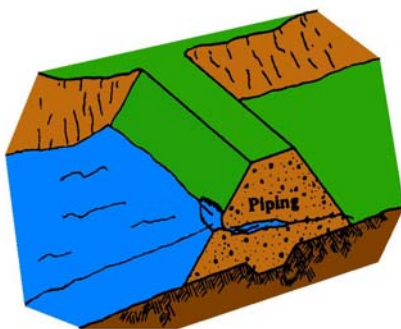
SINKHOLE

The piping of embankment material or foundation material causes a sink hole. The cave-in of an eroded cavern can result in a sink hole. A small hole in the wall of an outlet pipe can develop a sink hole.

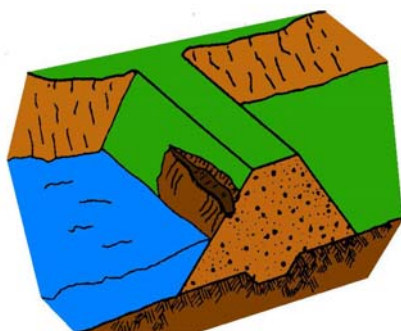
SLIDE, SLUMP, OR SLIP

Earth or rocks move down the slope along a slippage surface because they were on too steep a slope, or the foundation moves. Also, look for slides in reservoir basin.

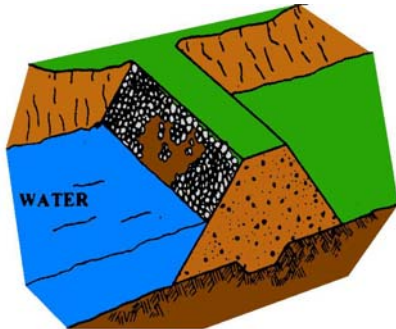
BROKEN DOWN, MISSING RIPRAP

Poor quality riprap has deteriorated. Wave action or ice action has displaced riprap. Round and similar sized rocks have rolled downhill.

Wave action against these unprotected areas decreases embankment width.

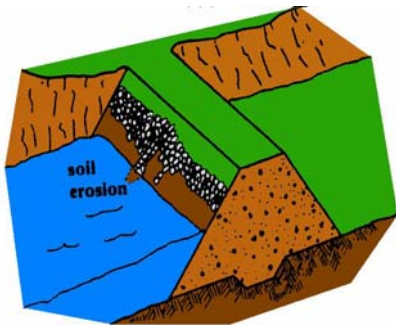
EROSION BEHIND POORLY GRADED RIPRAP

Similar-sized rocks allow waves to pass between them and erode small gravel particles and soil.

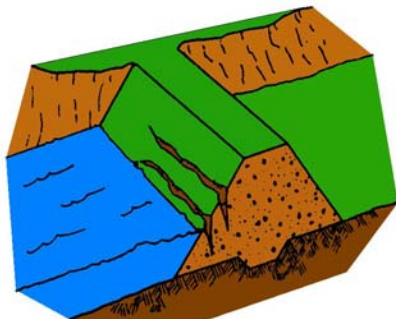
LARGE CRACKS ON SLOPE

A portion of the embankment has moved due to loss of strength, or the foundation may have moved, causing embankment movement.

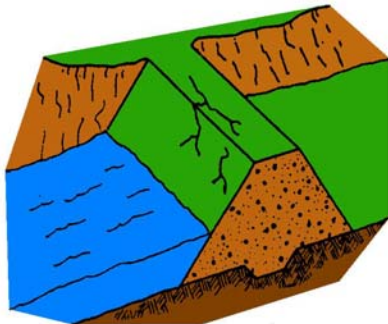
CRACKS DUE TO DRYING

The soil loses its moisture and shrinks, causing cracks.

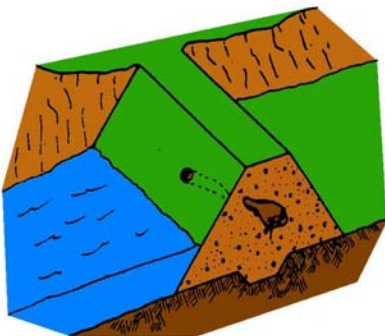
BEAVER OR MUSKRAT ACTIVITY

Holes, tunnels, and caverns are caused by animal burrows. Certain habitats like cattail-type plants and trees close to the reservoir encourage these animals.

Remove rodents. Determine exact location of digging and extent of tunneling. Remove habitat. Repair damages.

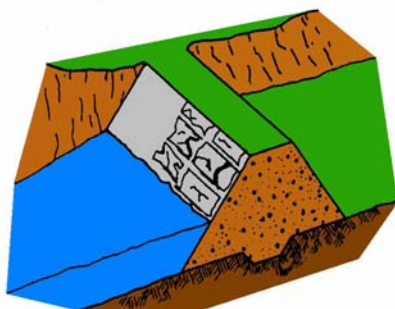
CRACKED DETERIORATED CONCRETE FACE

Concrete deteriorated due to weathering. Joint filler deteriorated or displaced.

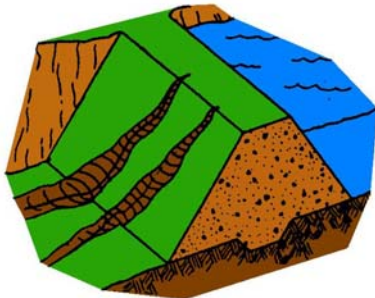
EROSION

1. The preferred method to protect eroded areas is rock or riprap.
2. Re-establishing protective grasses can be adequate if the problem is detected early.

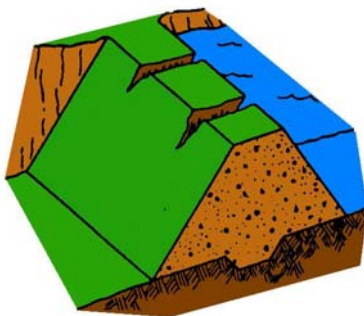
TRANSVERSE CRACKING AFFECTING SLOPE

1. Drying and shrinkage of surface material is most common.
2. Differential settlement of the embankment also leads to transverse cracking (e.g., center settles more than abutments).

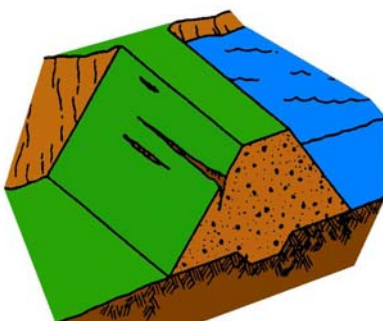
LONGITUDINAL CRACKING ON SLOPE

1. Drying and shrinkage of surface material.
2. Downstream movement or settlement of embankment.

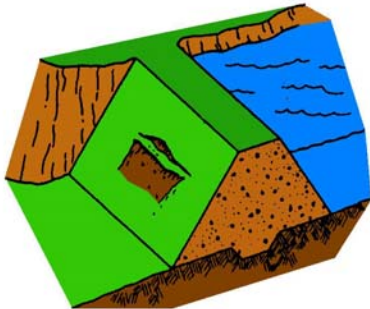
SLIDE/SLOUGH

1. Lack of or loss of strength of embankment material.
2. Loss of strength can be attributed to infiltration of water into the embankment or loss of support by the foundation.

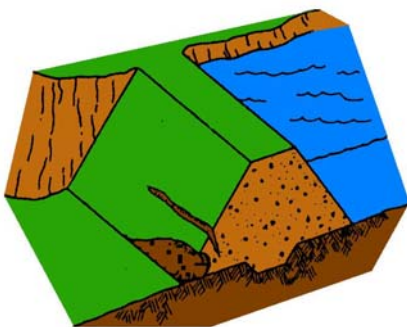
SLUMP (LOCALIZED CONDITION)

Preceded by erosion undercutting a portion of the slope. Can also be found on relatively steep slopes.

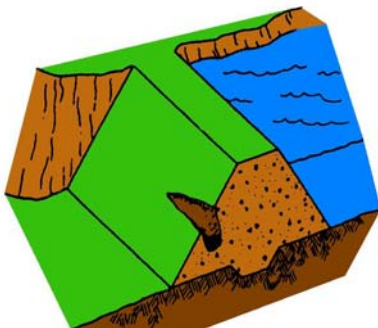
SINK HOLE/COLLAPSE

Lack of adequate compaction; rodent hole below; piping through embankment or foundation.

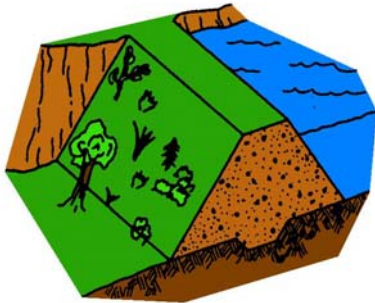
TREES/OBSCURING BRUSH

Natural vegetation in area.

1. Remove all large, deep-rooted trees and shrubs on or near the embankment. Properly backfill void.
2. Control all other vegetation on the embankment that obscures visual inspection.

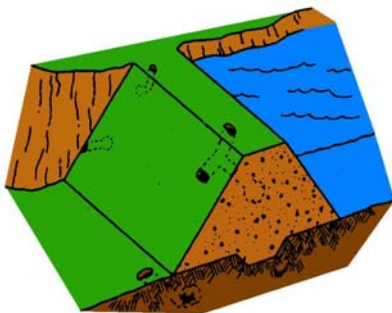
RODENT ACTIVITY ON SLOPE

Overabundance of rodents.

1. Control rodents to prevent additional damage.
2. Backfill existing rodent holes.

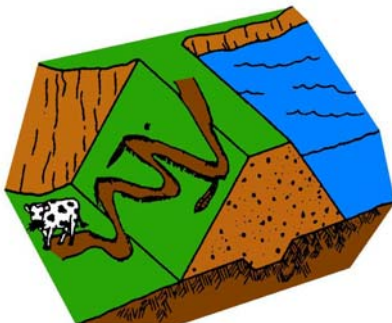
LIVESTOCK/CATTLE TRAFFIC

Excessive travel by livestock especially harmful to slope when wet.

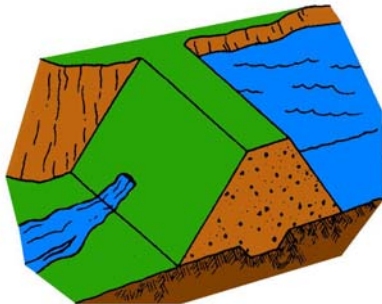
MUDDY WATER EXITING FROM A POINT SOURCE

1. Water has created an open pathway, channel, or pipe through the dam. The water is eroding and carrying embankment material.
2. Large amounts of water have accumulated in the downstream slope. Water and embankment materials are exiting at one point. Surface agitation may be causing the muddy water.

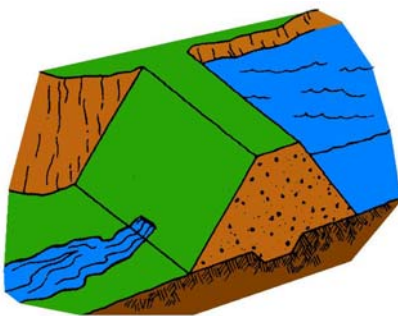
WATER EXITING FROM A POINT SOURCE

Water has created an open pathway or pipe through the dam.

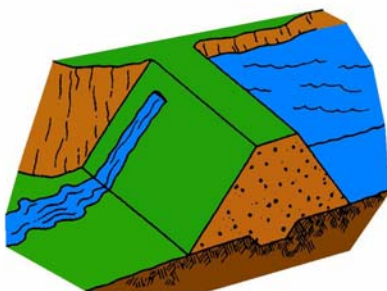
WATER EXITING FROM A POINT SOURCE HIGH ON THE EMBANKMENT

1. Rodents, frost action, or poor construction have allowed water to create an open pathway or pipe through the embankment.

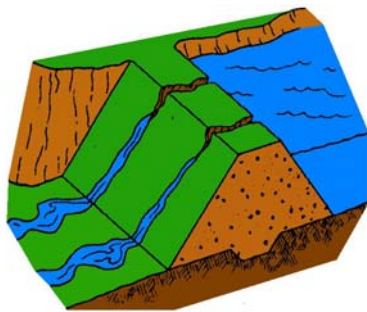
STREAM OF WATER EXITING THROUGH CRACKS NEAR THE CREST

1. Severe drying has caused shrinkage of embankment material.
2. Settlement in the embankment or foundation is causing the transverse cracks.

Flow through the crack can cause failure of the dam.

1. Plug the upstream side of the crack to stop the flow.
2. The water level in the reservoir should be lowered until it is below the level of the cracks.
3. A qualified engineer should inspect the condition and recommend further actions to be taken.

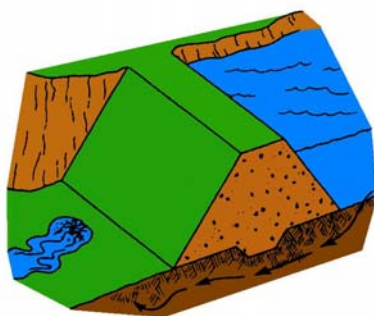
SEEPAGE WATER EXITING AS A BOIL IN THE FOUNDATION

Some portion of the foundation material is providing a flow path. This could be caused by a sand or gravel layer in the foundation.

Increased flows can lead to erosion of the foundation and failure of the dam.

1. Examine the boil for transportation of foundation materials.
2. If soil particles are moving downstream, sandbags or earth should be used to create a dike around the boil. The pressure created by the water level within the dike may control flow velocities and temporarily prevent further erosion.
3. If erosion is becoming greater, the reservoir level should be lowered.
4. A qualified engineer should inspect the condition and recommend further actions to be taken.

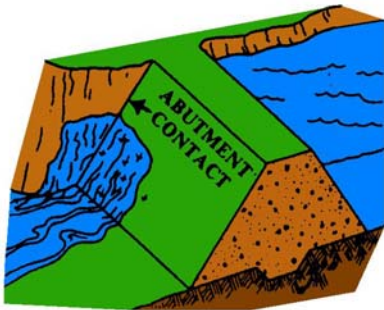
SEEPAGE EXITING AT ABUTMENT CONTACT

1. Water flowing through pathways in the abutment.
2. Water flowing through the embankment.

Can lead to erosion of embankment materials and failure of the dam.

1. Investigate leakage area to determine quantity of flow and extent of saturation.
2. Inspect daily for developing slides.
3. Water level in reservoir may need to be lowered to assure the safety of the embankment.
4. A qualified engineer should inspect the conditions and recommend further actions to be taken.

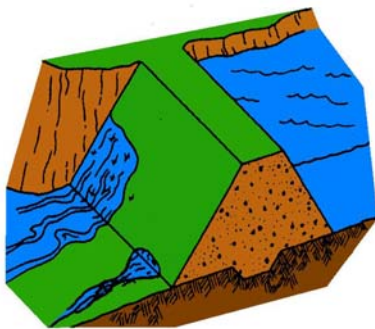
LARGE AREA WET OR PRODUCING FLOW

A seepage path has developed through the abutment or embankment.

1. Increased flows could lead to erosion of embankment material and failure of the dam.
2. Saturation of the embankment can lead to local slides which could cause failure of the dam.

1. Stake out the saturated area and monitor for growth or shrinking.
2. Measure any outflows as accurately as possible.
3. Reservoir level may need to be lowered if saturated areas increase in size at a fixed storage level or if flow increases.
4. A qualified engineer should inspect the condition and recommend further actions to be taken.

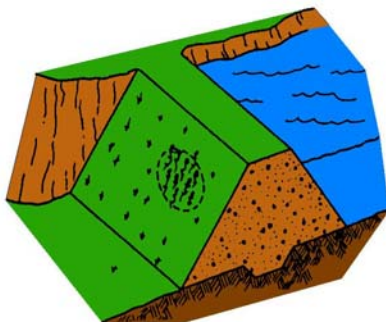
MARKED CHANGED IN VEGETATION

1. Embankment materials are providing flow paths.
2. Natural seeding by wind.
3. Change in seed type during initial post construction seeding.

1. Use probe and shovel to establish if the materials in this area are wetter than in surrounding areas.
2. If area shows wetness when surrounding areas do not, a qualified engineer should inspect the condition and recommend further actions to be taken.

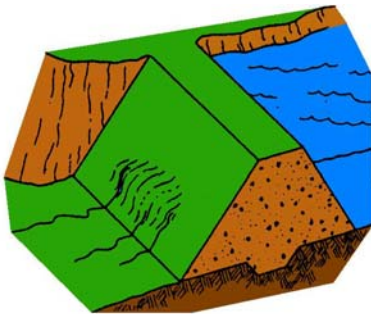
BULGE IN LARGE WET AREA

Downstream embankment materials have begun to move.

Failure of the embankment due to massive sliding can follow these initial movements.

1. Compare embankment cross-section to the end of construction condition to see if observed condition may reflect end of construction.
2. Stake out affected area and accurately measure outflow.
3. A qualified engineer should inspect the condition and recommend further actions to be taken.

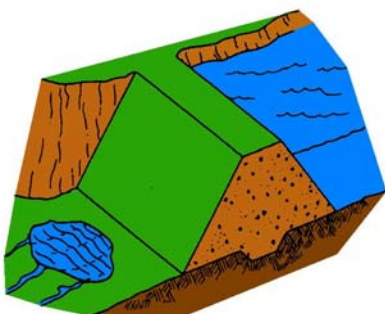
TRAMPOLINE EFFECT IN LARGE SOGGY AREA

Water moving rapidly through the embankment or foundation is being controlled or contained by a well-established turf root system.

Condition indicates excessive seepage in the area. If control layer of turf is destroyed, rapid erosion of foundation materials could result in failure of the dam.

1. Carefully inspect the area for outflow quantity and any transported materials.
2. A qualified engineer should inspect the condition and recommend further actions to be taken.

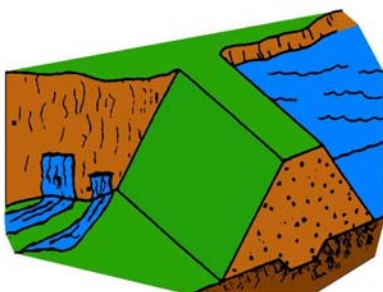
LEAKAGE FROM ABUTMENTS BEYOND THE DAM

Water moving through cracks and fissures in the abutment materials.

1. Carefully inspect the area to determine quantity of flow and amount of transported material.
2. A qualified engineer or geologist should inspect the condition and recommend further actions to be taken.

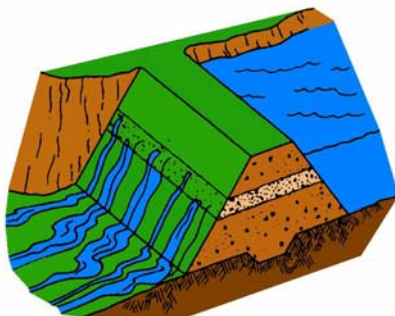
WET AREA IN HORIZONTAL BAND

Frost layer or layer of sandy material in original construction.

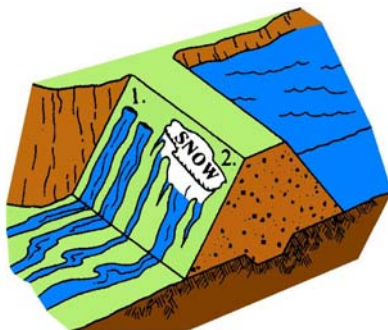
LARGE AREA SATURATED FROM ABOVE

1. Water flowing through the embankment.
2. Snowdrifts melting slowly during mild spring temperatures.

Can lead to saturation of embankment materials and local or massive slides which could cause failure of the dam.
