**FAWN LAKE
INUNDATION ZONES**

Dewberry

August 3, 2017

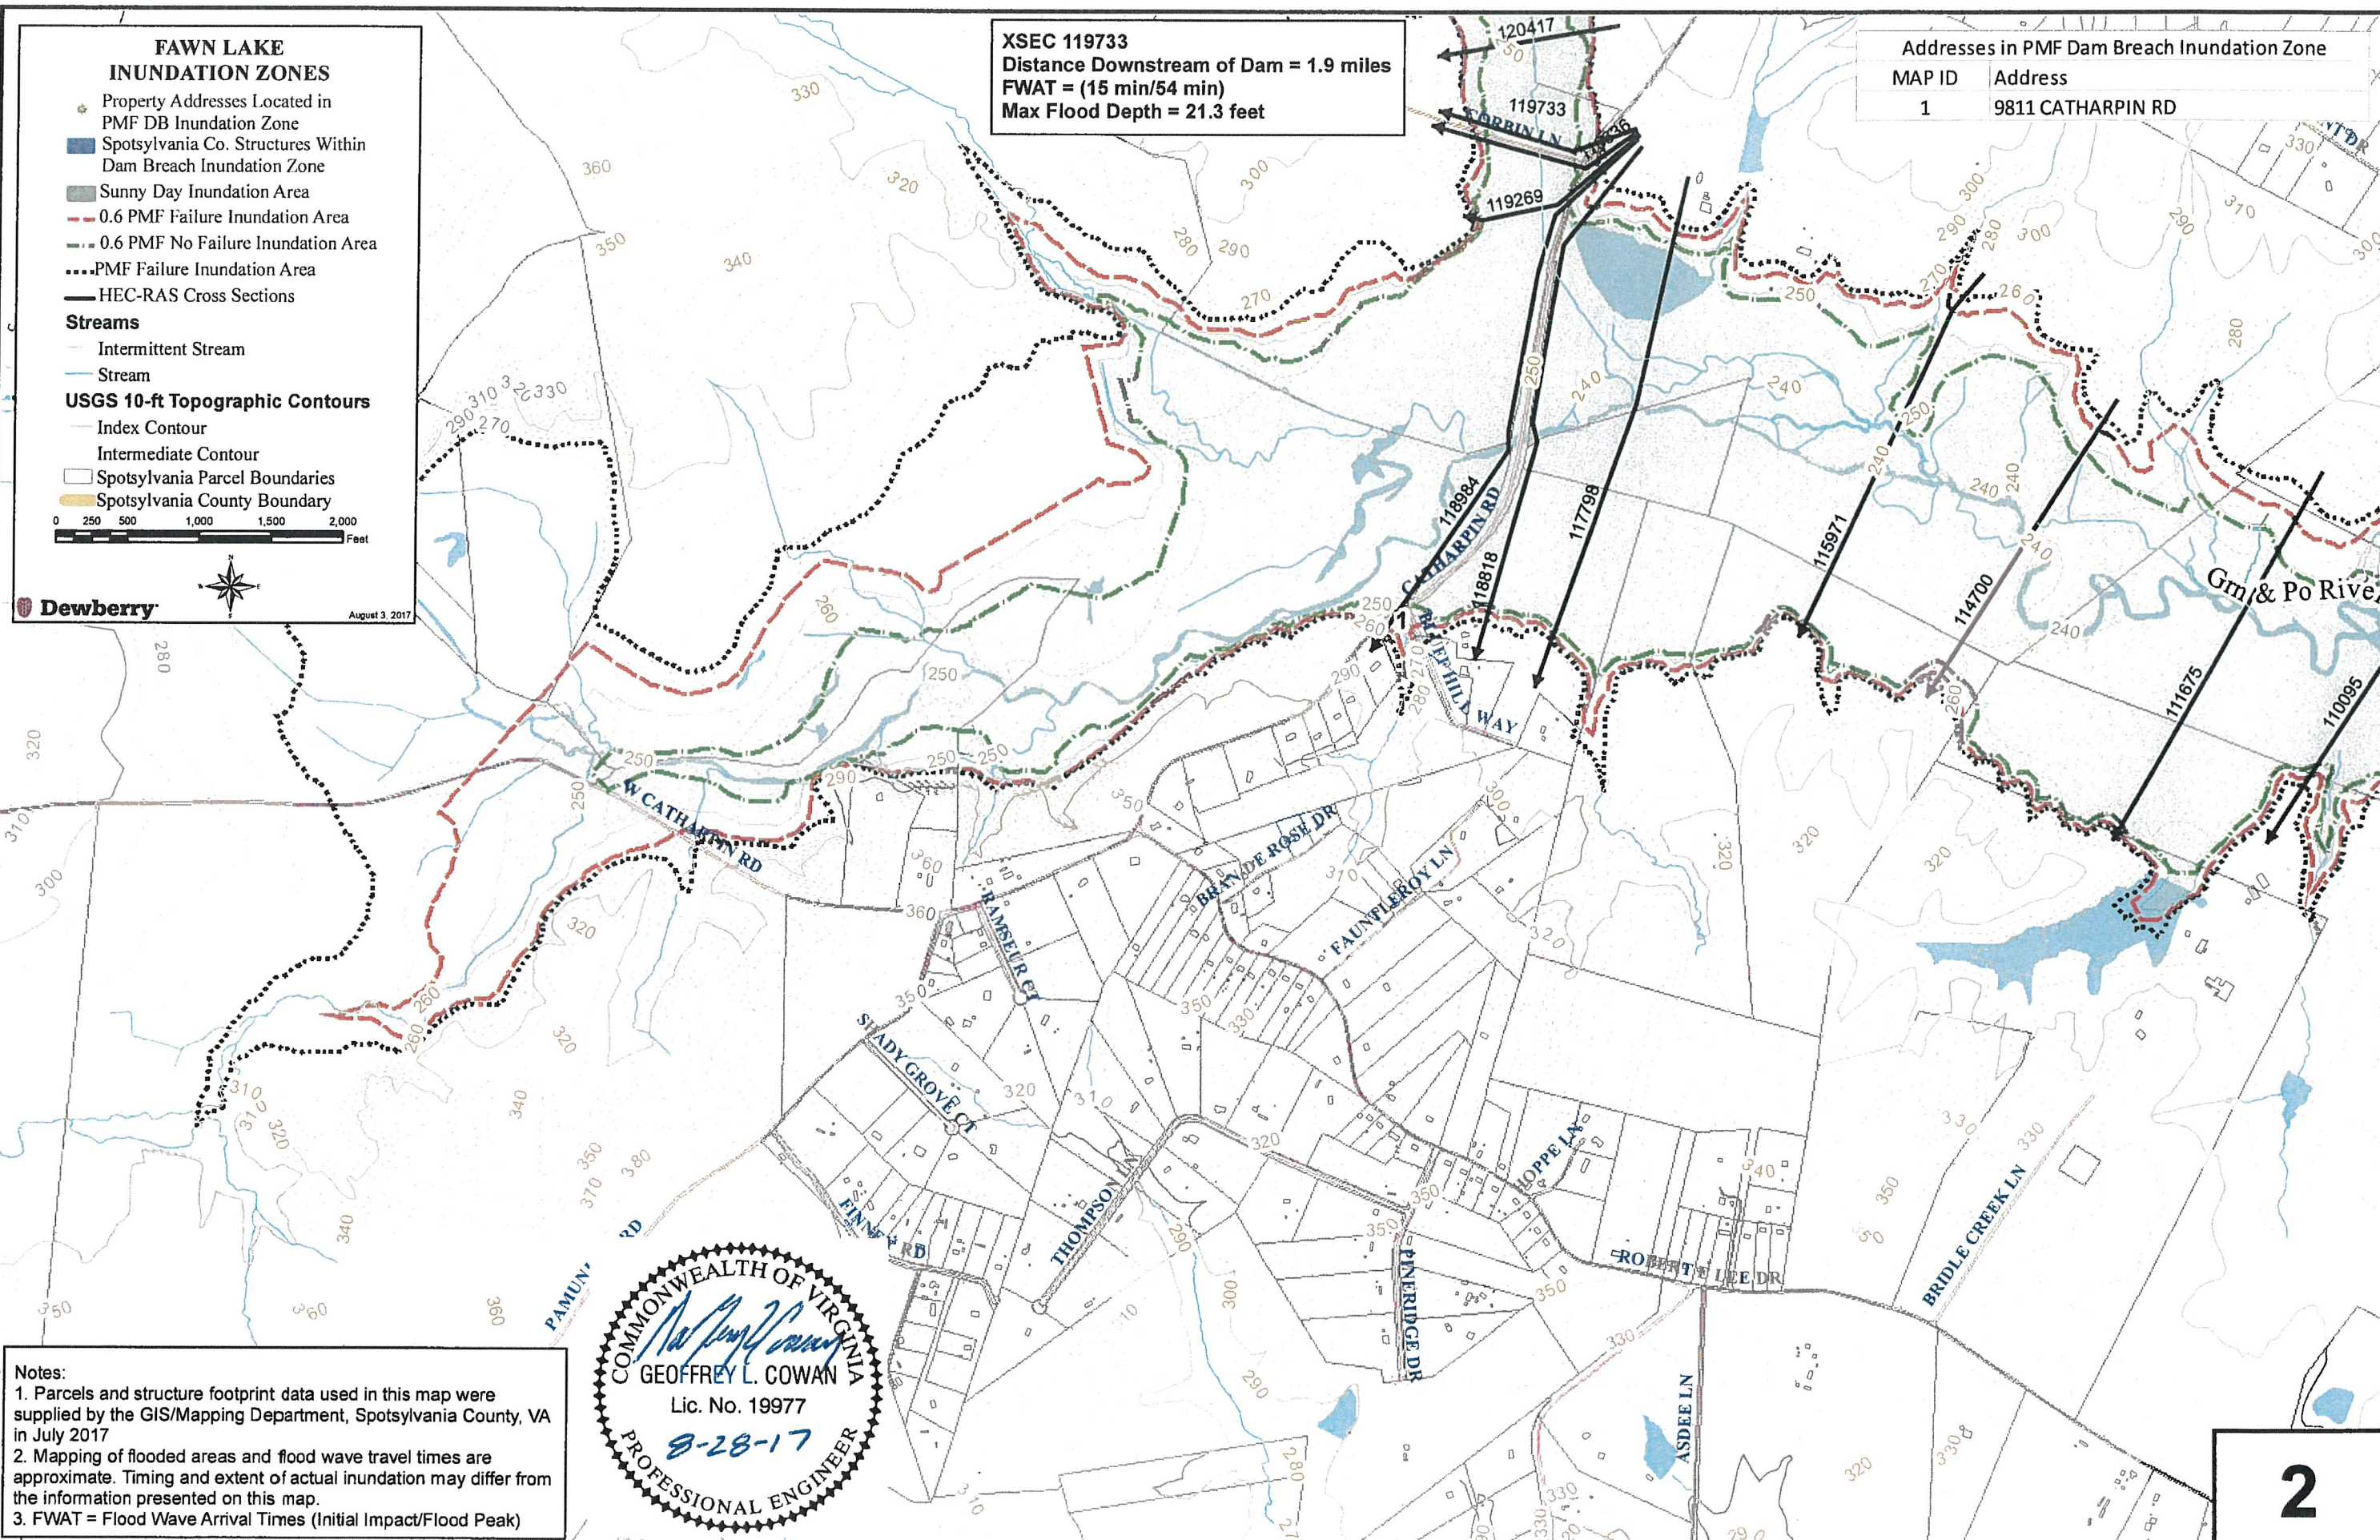
XSEC 119733
Distance Downstream of Dam = 1.9 miles
FWAT = (15 min/54 min)
Max Flood Depth = 21.3 feet

Addresses in PMF Dam Breach Inundation Zone	
MAP ID	Address
1	9811 CATHARPIN RD
