**FAWN LAKE
INUNDATION ZONES**

Addresses in PMF Dam Breach Inundation Zone

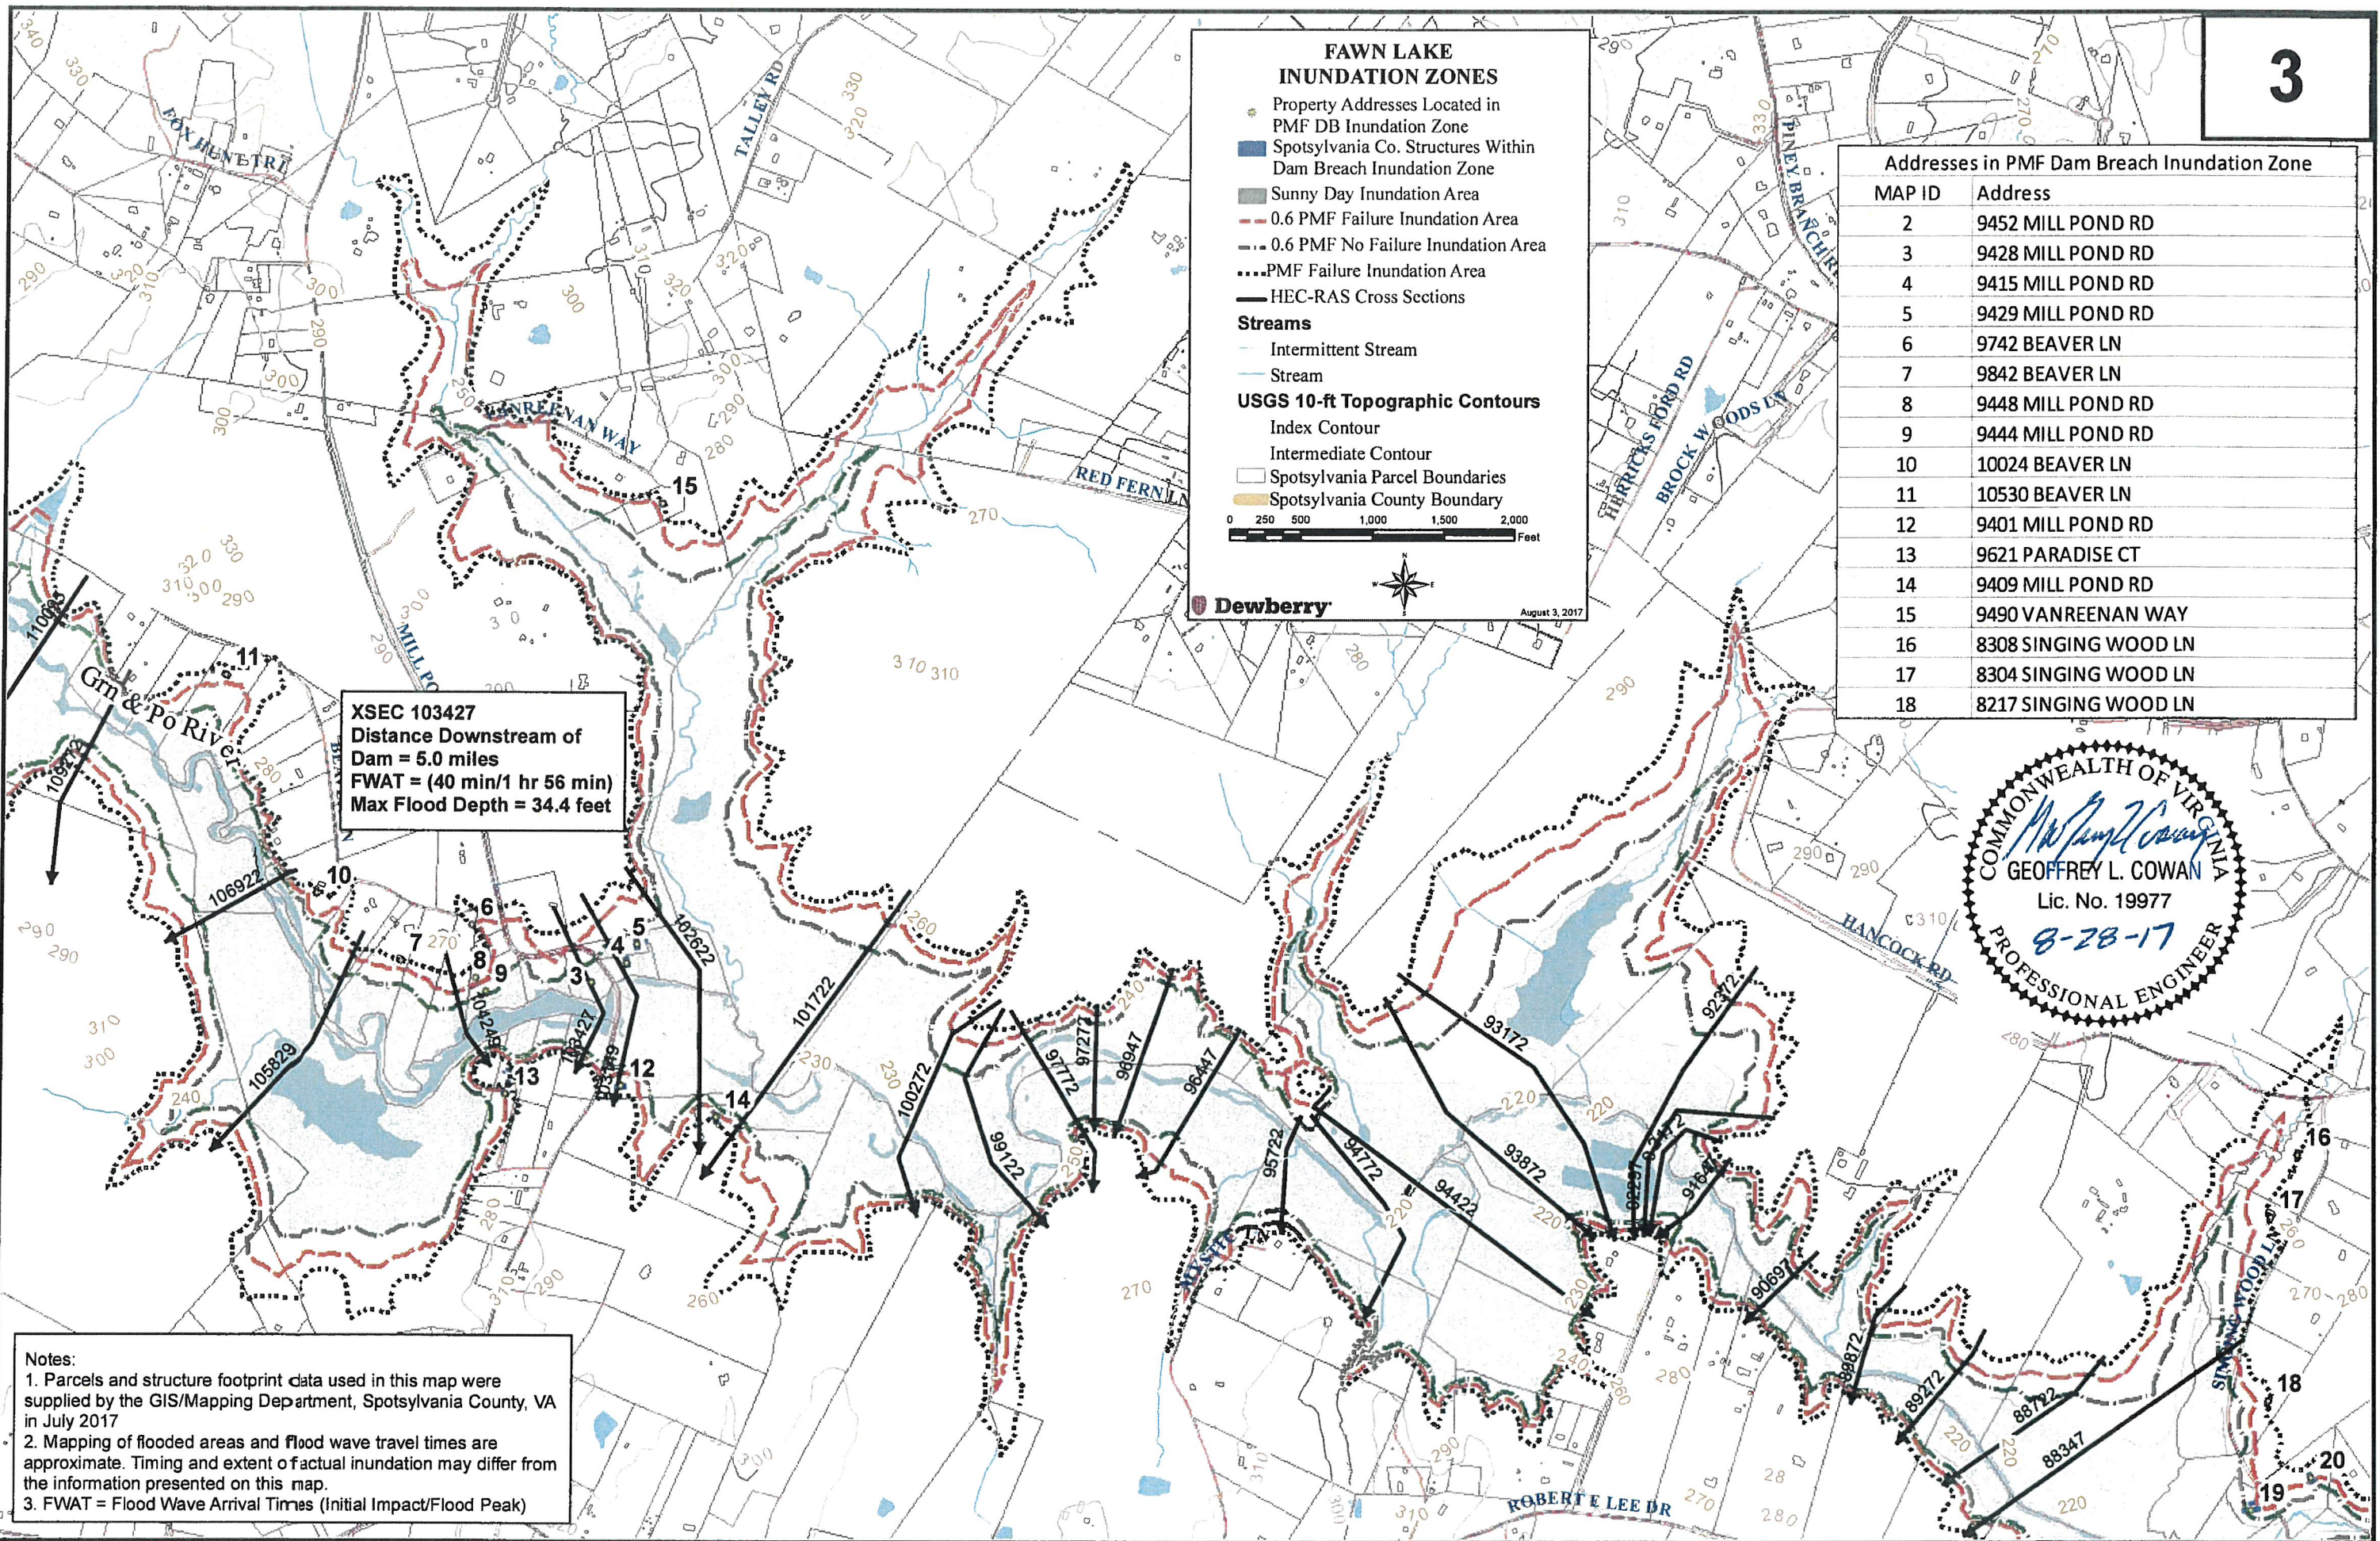
XSEC 103427
 Distance Downstream of Dam = 5.0 miles
 FWAT = (40 min/1 hr 56 min)
 Max Flood Depth = 34.4 feet
