Addresses in PMF Dam Breach Inundation Zone	
MAP ID	Address
42	8521 HERON POINTE WAY
43	9510 NORTHLAKE DR
44	9430 NORTHLAKE DR

FAWN LAKE INUNDATION ZONES

August 3, 2017

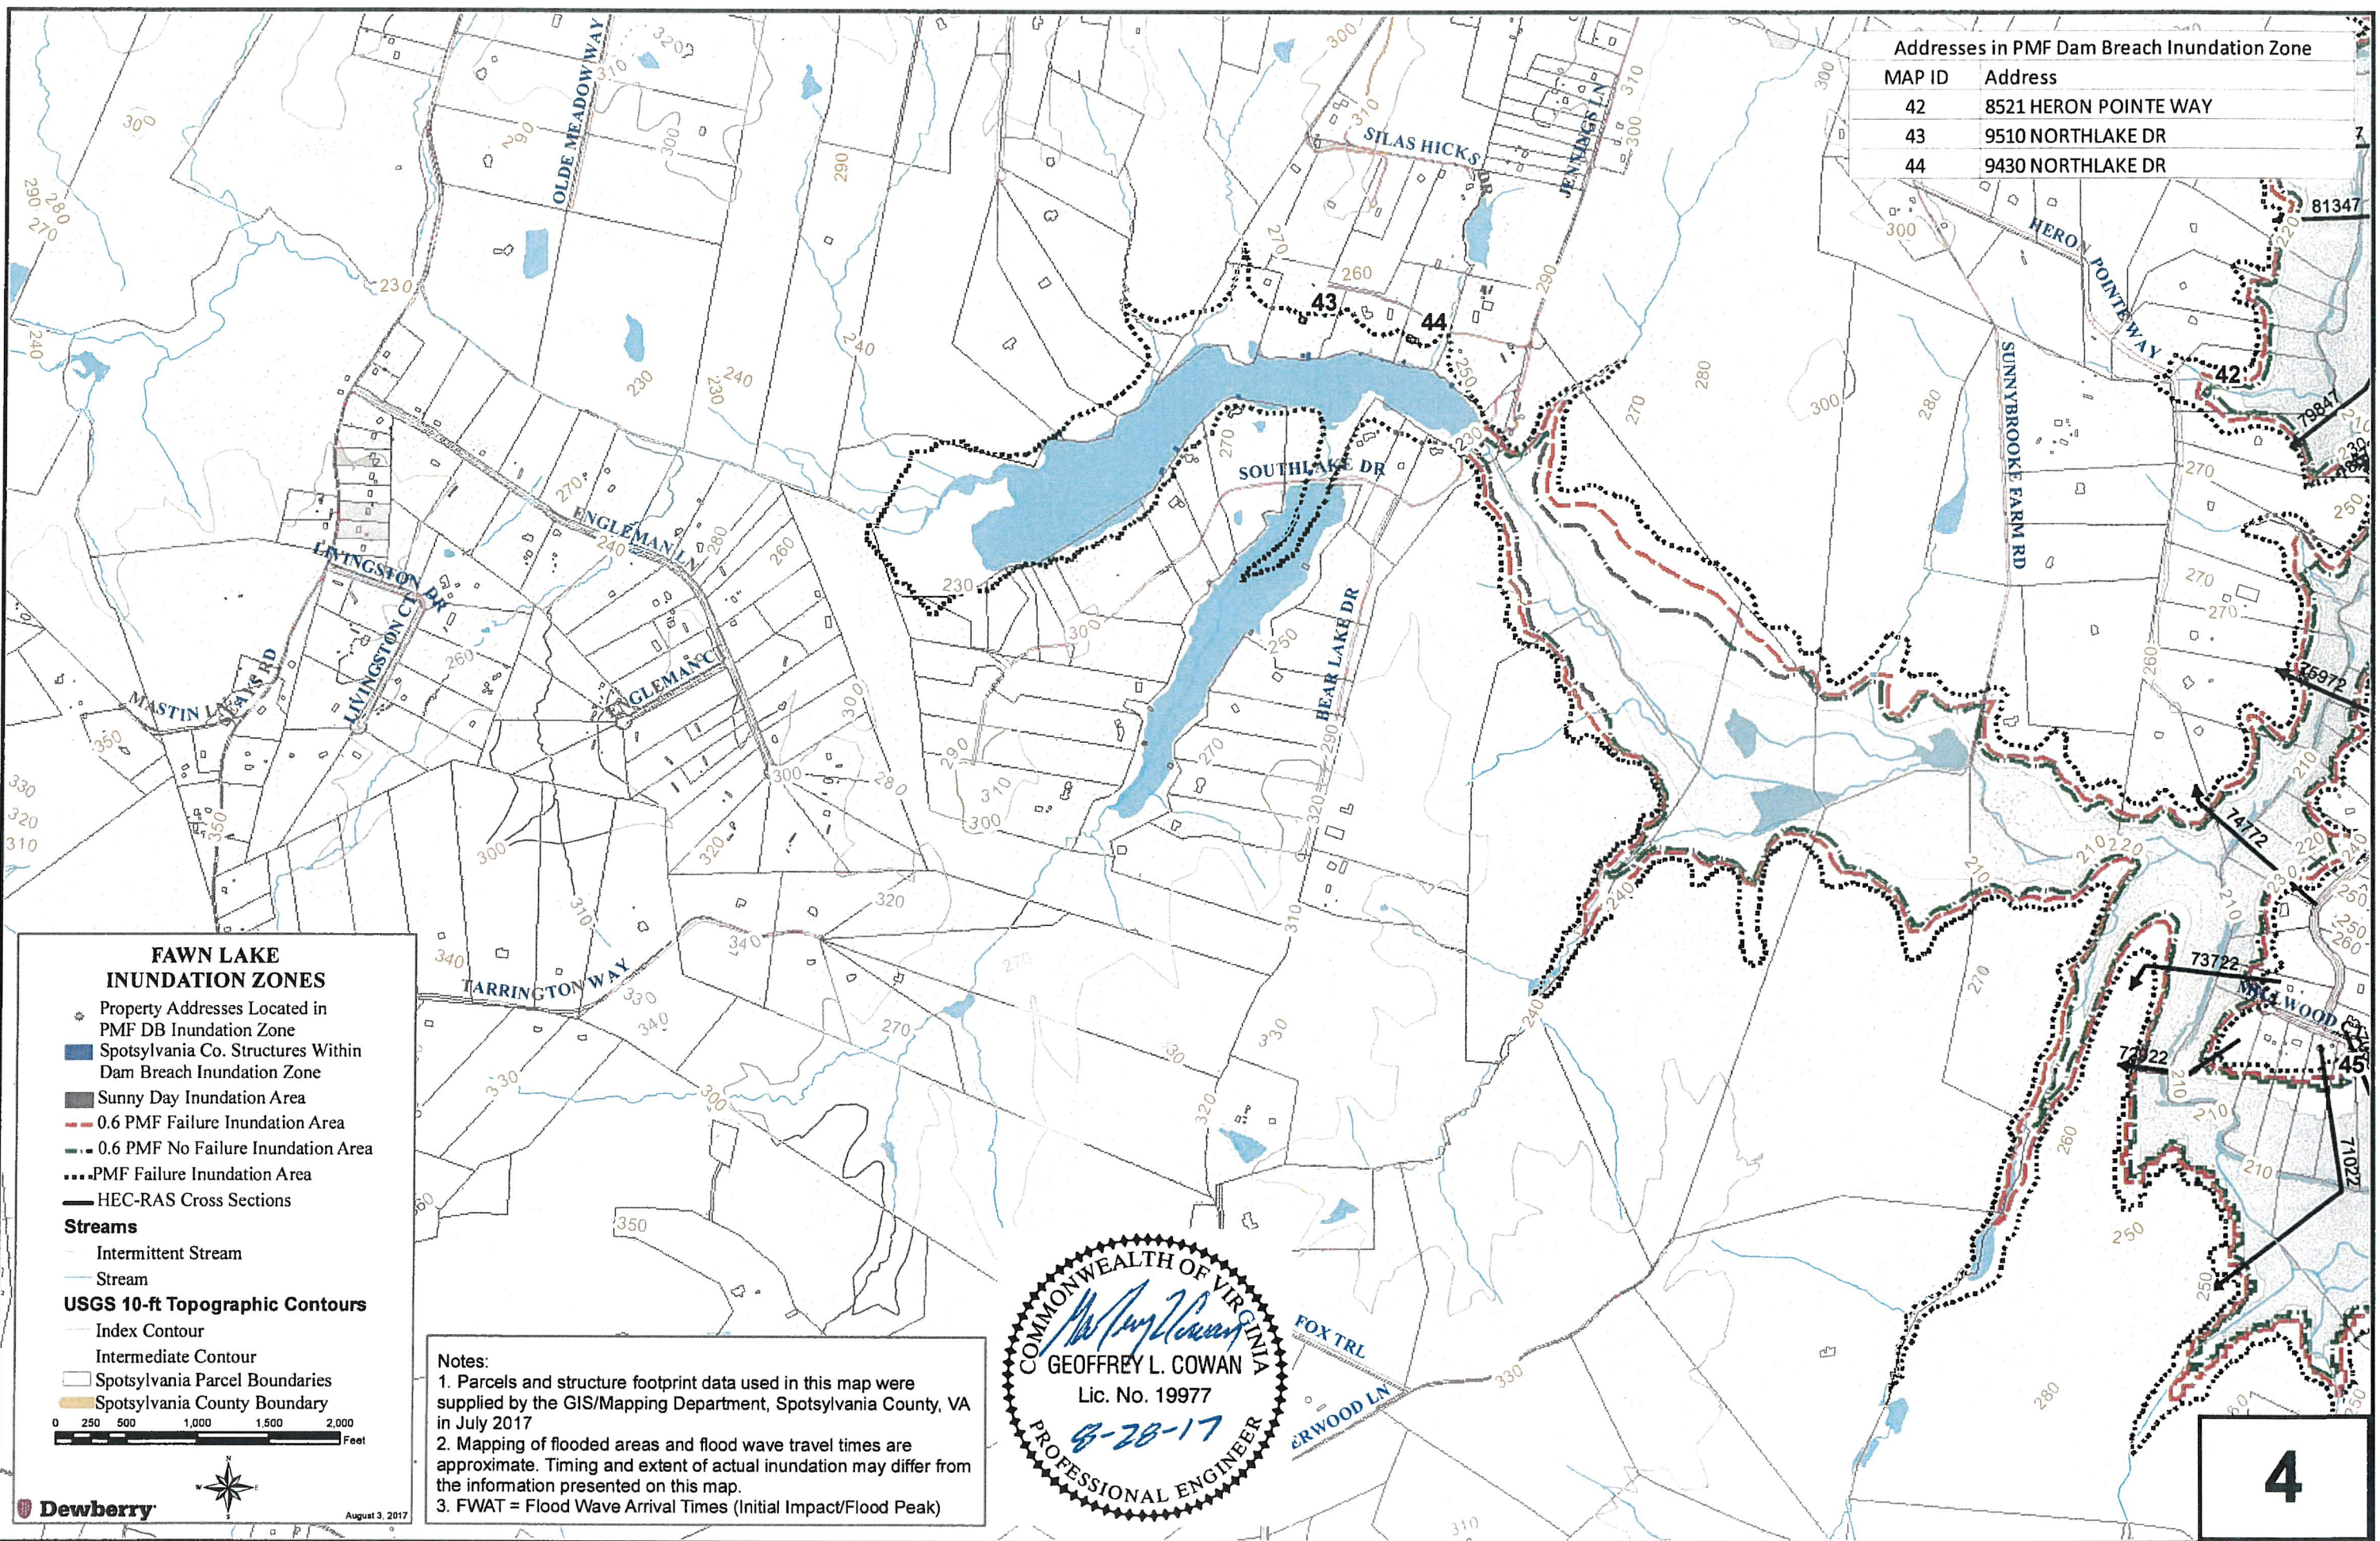
Notes:
 1. Parcels and structure footprint data used in this map were supplied by the GIS/Mapping Department, Spotsylvania County, VA in July 2017
 2. Mapping of flooded areas and flood wave travel times are approximate. Timing and extent of actual inundation may differ from the information presented on this map.
 3. FWAT = Flood Wave Arrival Times (Initial Impact/Flood Peak)
